Long Term Performance of Soloflo drainit Wedge Design

2010 Inspection of Sub-Soil Drainage Pipe Installed at Meerlust Wine Estates in 1985.

by Falk Hedrich, Geosynthetic Technology Consultant, RSA

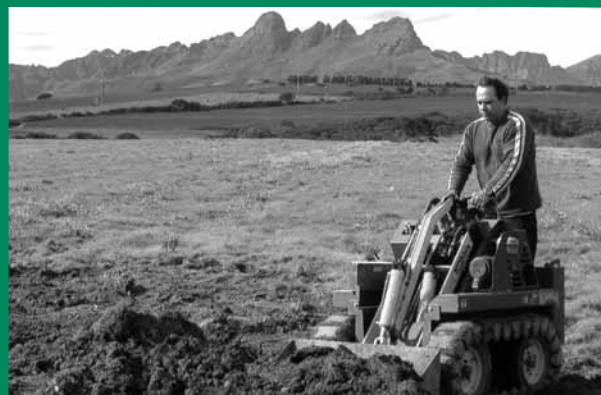
Excavation of Pipe

With the help of a small earthworks machine we removed the soil to a depth of approximately 800 mm and carefully hand-tool excavated to the top of the pipe to avoid damage. The 200 mm main drainage pipe was exposed at two different places, namely 15 meters and 45 meters from the manhole exit. We did not deem it necessary to excavate towards the smaller free flowing pipes. Soil samples were taken from above the pipe, namely 80 mm and 800 mm away from the pipe. Four samples were taken in total – two at each location. No free water was present around the pipe. On average the pipe was covered by a mixture of soil consisting of 5 – 10% clay, 10 – 20% silt, 37-45 % sand and 34-41% gravel and a plasticity index of between 9 and 11.

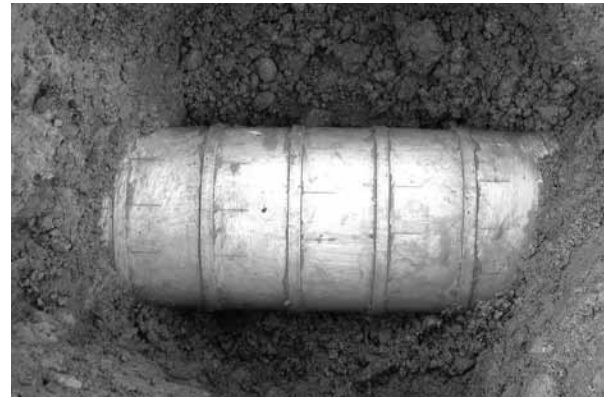
Fig. 1 - No Filter Stone, No Geotextile

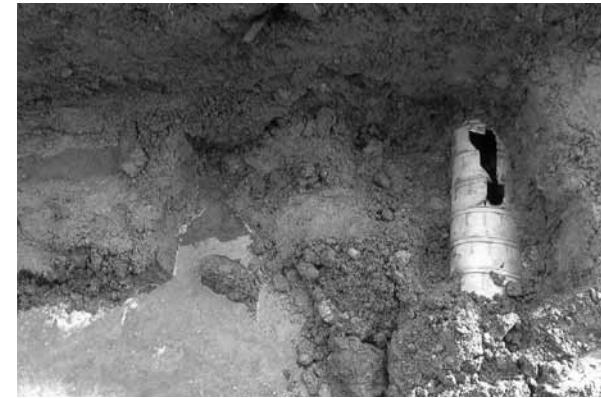
A further pipe section was exposed approximately 50 meters away from the manhole for the purpose of opening the top of the pipe to retrieve A.B.S samples and to inspect the inside of the pipe manually. The small pieces of soil visible in the picture of the opened up pipe are soil particles which fell into

the pipe when it was opened (*Fig. 2*). The water level and the inner wedge slot opening can be clearly seen (*Fig. 3*). Small root growth visible in the pipe was only noticed in 2 or 3 places. No root growth network was present in the pipe.

Fig. 2 - No Standing Water Around Pipe

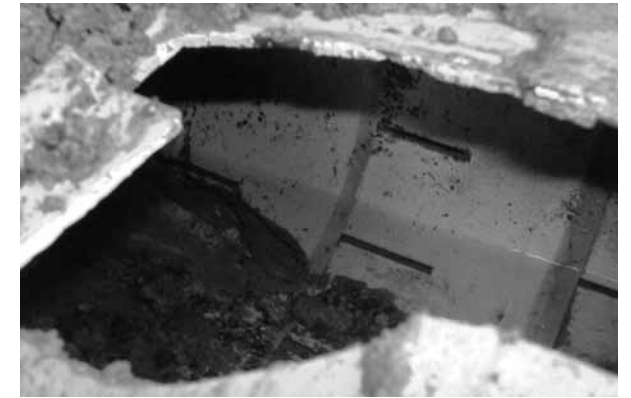
Fig. 3 - Flush I.D. Joints and Wedge Design Openings

circumference of the pipe where drainage water can enter the pipe. A further contributing factor is that the inside of the pipe is flush, free of stepped joints or flow hindering connections (Fig. 3). The TV camera could enter the pipe for a distance of 26 meters which was the limit of the inspection capacity.
